NOTICE TO BUYER: SELLER-PROCURED INSPECTION REPORT

13506 174th Ave NE

Redmond, WA 98052

At your request, a visual inspection of the above referenced property was conducted on 03/25/2021. We have inspected the major structural components, plumbing, heating and electrical systems for signs of significant non-performance, excessive or unusual wear and general state of repair.

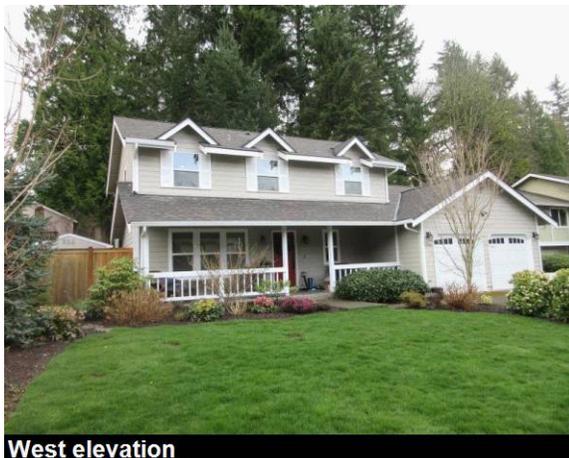
1.6 ADDRESS OF PROPERTY INSPECTED

13506 174th Ave. NE
Redmond WA.

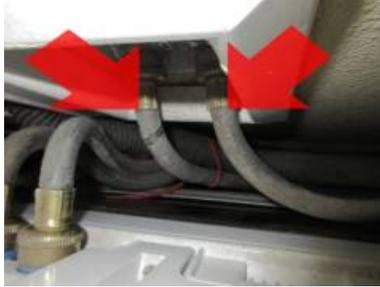
The hookups for the dryer are properly installed and in serviceable condition. The dryer itself was operated through a partial cycle, however we did not confirm the complete operation of the cycle timer.

Upgrading the washer connections to high pressure (steel braided) lines is recommended.
