### NOTICE TO BUYER: SELLER-PROCURED INSPECTION REPORT

**Christopher and Rebekah Eldridge**

**13843 174<sup>th</sup> PL NE**

At your request, a visual inspection of the above referenced property was conducted on 04/20/2021. We have inspected the major structural components, plumbing, heating and electrical systems for signs of significant non-performance, excessive or unusual wear and general state of repair.

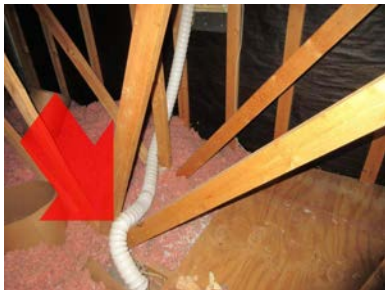
Flexible plastic duct is used to direct air from the vent fans to the exterior. This type of material is unreliable. Replacing the plastic duct with 4" smooth-wall sheet metal duct is recommended.

An attic fan was installed for whole house ventilation. This fan was not tested.

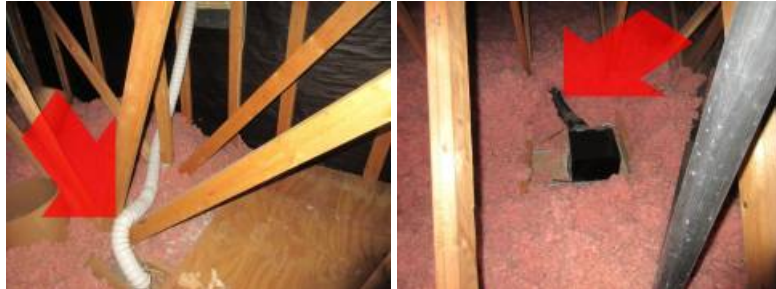
Flexible plastic duct is used to direct air from the vent fans to the exterior. This type of material is unreliable. Replacing the plastic duct with 4" smooth-wall sheet metal duct is recommended.

An attic fan was installed for whole house ventilation. This fan was not tested.
