NOTICE TO BUYER: SELLER-PROCURED INSPECTION REPORT

The following notice is given with respect to the Purchase and Sale Agreement dated _____ between _____ ("Buyer") and **Taylor Trust** _____ ("Seller") concerning **31780 Ne 171st St Duvall WA 98019** ("the Property").

March 9, 2022

Re: 31780 NE171st St.
Duvall, WA.

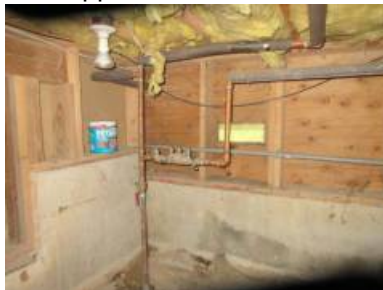
18.6 SHEAR PANELS

Shear panels are plywood or OSB panels that are mechanically fastened to both vertical and horizontal framing members in critical structural areas of the building. They prevent lateral movement of the structure during an earthquake. Shear panels are often visible in the crawlspace on cripple walls between the first floor and foundation. They may also be installed on interior walls that are covered with drywall. An examination of the crawlspace revealed the absence of shear panels on the cripple walls. The installation of shear panels on the cripple walls is recommended as an upgrade.
