## NOTICE TO BUYER: SELLER-PROCURED INSPECTION REPORT

April 20, 2022

**Re: 13716 175th Court NE**  
**Redmond, WA.**

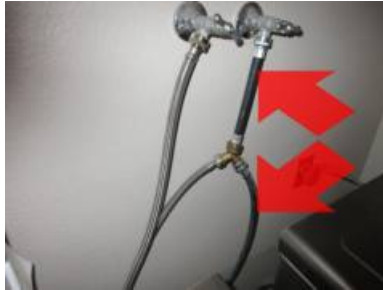
The hookups for the dryer are properly installed and in serviceable condition. The dryer itself was operated through a partial cycle, however we did not confirm the complete operation of the cycle timer.

Upgrading the washer connections to high pressure (steel braided) lines is recommended.
