Kyle Whitson and Dana Mauricio

13810 174th Place NE, Redmond, WA 98052

NOTICE TO BUYER: SELLER-PROCURED INSPECTION REPORT

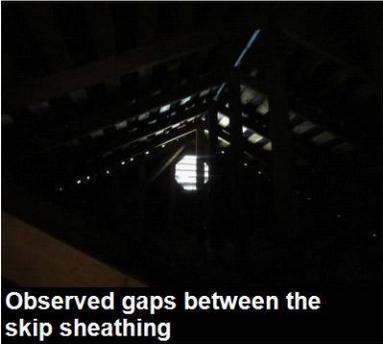
There are openings adjacent the ends of the outlook boards under the overhang through which insects and rodents can enter into the attic. These openings should be covered with wood, wire mesh or filled with aerosol

foam.

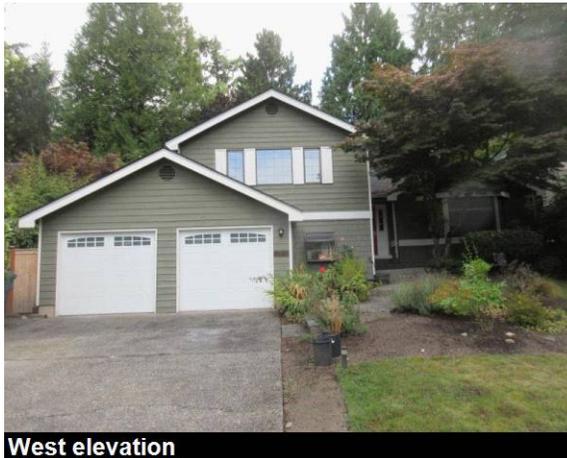
West elevation

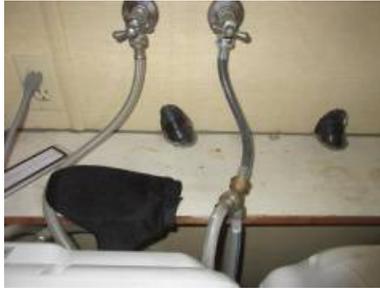
The hookups for the dryer are properly installed and in serviceable condition. The dryer itself was operated through a partial cycle, however we did not confirm the complete operation of the cycle timer.

Upgrading the washer connections to high pressure (steel braided) lines is recommended.
