**NOTICE TO BUYER: SELLER-PROCURED INSPECTION REPORT**

The following notice is given with respect to the Purchase and Sale Agreement dated _____ between _____ ("Buyer") and **Marc Holleman** **Kerrie Holleman** ("Seller") concerning **14147 176th Ave NE** **Redmond** **WA 98052** ("the Property").

At your request, a visual inspection of the above referenced property was conducted on 09/24/2020. We have inspected the major structural components, plumbing, heating and electrical systems for signs of significant non-performance, excessive or unusual wear and general state of repair.

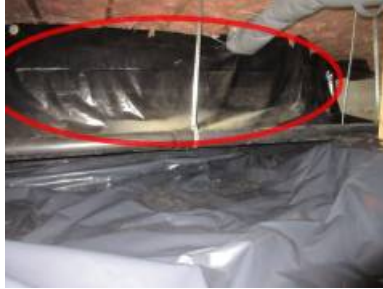
The support post concrete piers are covered with the plastic vapor retarder. This allows the transmission of water vapor from the soil up and into the floor framing. The plastic vapor retarder should be removed from the pier so that it covers at least 85% of the entire surface of the soil only.
