NOTICE TO BUYER: SELLER-PROCURED INSPECTION REPORT

The following notice is given with respect to the Purchase and Sale Agreement dated _____
between _____ (“Buyer”)
and Jeff and Valerie Hunter (“Seller”)
concerning 14135 175th Ave NE Redmond, Wa 98052 (“the Property”).

At your request, a visual inspection of the above referenced property was conducted on 02/02/2018. We have inspected the major structural components, plumbing, heating and electrical systems for signs of significant non-performance, excessive or unusual wear and general state of repair.

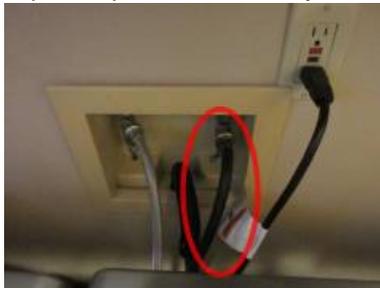
The hookups for the dryer are properly installed and in serviceable condition. The dryer itself was operated through a partial cycle, however we did not confirm the complete operation of the cycle timer.

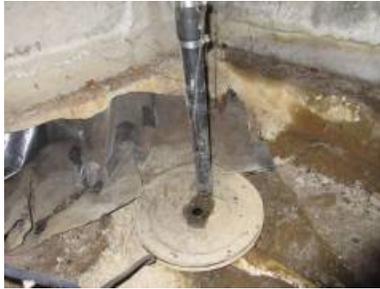
The soil was damp under the vapor barrier, however, no evidence of water intrusion or standing water problems was observed.

A sump pump has been installed to remove incoming ground water. The sump pump was tested and was operational.
