## **William and Brenda Millhollin**

15107 103<sup>rd</sup> Av NE, Bothell Wa. 98011

At your request, a visual inspection of the above referenced property was conducted on 05/16/2018. We have inspected the major structural components, plumbing, heating and electrical systems for signs of significant non-performance, excessive or unusual wear and general state of repair.

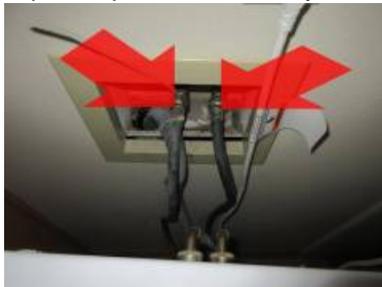
The hookups for the dryer are properly installed and in serviceable condition. The dryer itself was operated through a partial cycle, however we did not confirm the complete operation of the cycle timer.

Upgrading the washer connections to high pressure (steel braided) lines is recommended.
