**NOTICE TO BUYER: SELLER-PROCURED INSPECTION REPORT**

**John and Margaret Nordmark  
12948 177<sup>th</sup> PI NE  
Redmond WA 98052**

April 14, 2019

**Re: 12948 177th Pl. NE  
Redmond, WA.**

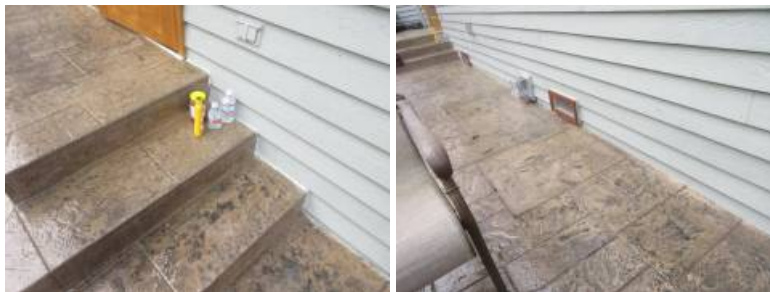
Untreated wood in direct contact with concrete was observed along the stoop and walkway. Untreated wood should be raised 1-2" above the concrete. Treating the wood with a preservative sometimes will prevent wood destroy organism

damage.

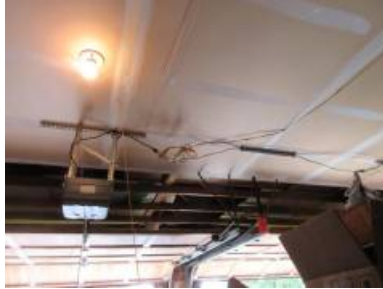
An extension cord is used as a temporary power source for the garage door openers. An extension cord is not suitable as a permanent wiring method. The installation of a receptacle within cords length of the motors is recommended.
