NOTICE TO BUYER: SELLER-PROCURED INSPECTION REPORT

The following notice is given with respect to the Purchase and Sale Agreement dated _____
between _____ (“Buyer”)
and Jonathan Dahlke and Melanie Muradian (“Seller”)
concerning 13828 174th Place NE, Redmond WA 98052 (“the Property”).

SELLERS' RESPONSES TO ACTION ITEMS, SIGNIFICANT DEFECTS AND/OR HEALTH AND SAFETY ISSUES IDENTIFIED IN 10/08/19 INSPECTION REPORT

Melanie Muradian and Jonathan Dahlke
13828 174th Place NE
Redmond, WA 98052

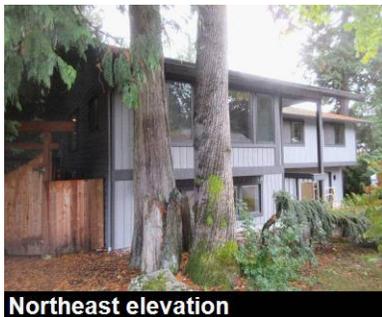
Northeast elevation

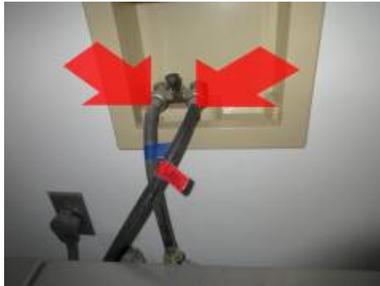
The hookups for the dryer are properly installed and in serviceable condition. The dryer itself was operated through a partial cycle, however we did not confirm the complete operation of the cycle timer.

Upgrading the washer connections to high pressure (steel braided) lines is recommended.
