NOTICE TO BUYER: SELLER-PROCURED INSPECTION REPORT

Olaf and Sherri Hubel
14136 174th Place NE
Redmond, WA 98052

At your request, a visual inspection of the above referenced property was conducted on 09/30/2019. We have inspected the major structural components, plumbing, heating and electrical systems for signs of significant non-performance, excessive or unusual wear and general state of repair.

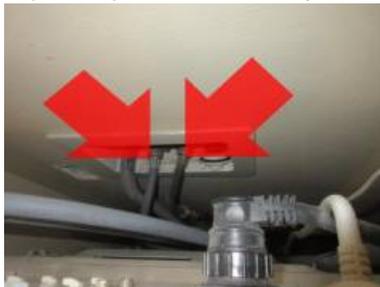
The hookups for the dryer are properly installed and in serviceable condition. The dryer itself was operated through a partial cycle, however we did not confirm the complete operation of the cycle timer.

Upgrading the washer connections to high pressure (steel braided) lines is recommended.
