NOTICE TO BUYER: SELLER-PROCURED INSPECTION REPORT

**Steve & Patti Nelson
17409 NE 141st Street
Redmond, WA 98052**

At your request, a visual inspection of the above referenced property was conducted on 07/28/2020. We have inspected the major structural components, plumbing, heating and electrical systems for signs of significant non-performance, excessive or unusual wear and general state of repair.

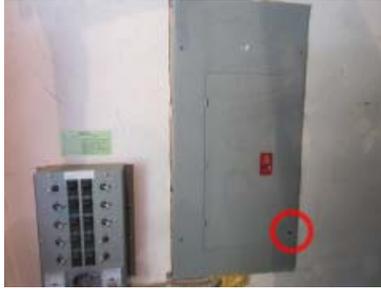
Screws that secure the panel cover to the panel box are missing. This is a potential hazard. Missing screws should be replaced with the original style blunt end screws.

The circuits are labeled. The accuracy of the labeling was not verified. Do not assume the labeled circuit is off unless it has been checked with a voltage tester.

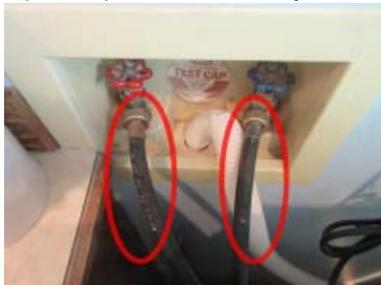
The hookups for the dryer are properly installed and in serviceable condition. The dryer itself was operated through a partial cycle, however we did not confirm the complete operation of the cycle timer.

High pressure (steel braided) washer line connections is recommended.
