NOTICE TO BUYER: SELLER-PROCURED INSPECTION REPORT

At your request, a visual inspection of the above referenced property was conducted on 10/15/2020. We have inspected the major structural components, plumbing, heating and electrical systems for signs of significant non-performance, excessive or unusual wear and general state of repair.

14151 177th Ave. NE
Redmond WA.

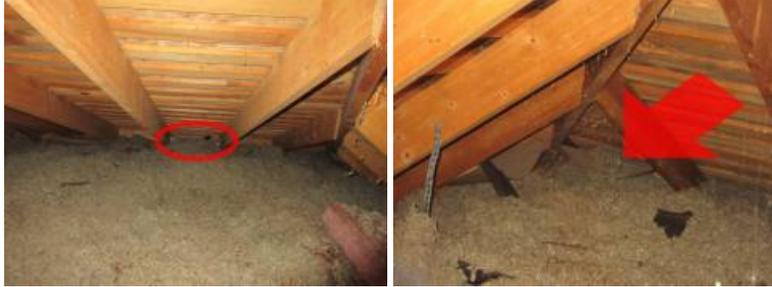
When water vapor comes in contact with cold surfaces of the roof sheathing and framing it condenses and remains as water. This water can drip down on the insulation and decrease its effectiveness, will rot or deteriorate roof sheathing, cause mold and mildew growth, cause plaster or wall board to crack, paint to peel and will reduce the serviceable life of the roofing material.

Pressure induced attic ventilation ie: attic fans, solar fans or other systems that mitigate moisture amounts may be necessary due to certain conditions found within some buildings. However the pressure increase or decrease of the ambient air of the living space may affect the performance of and/or venting of gas appliances or fireplaces when in use creating conditions may be hazardous to your health. These are designed systems that should be installed by a qualified contractor.

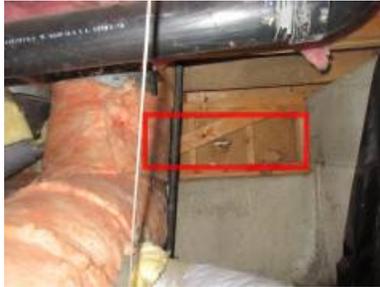
walls that are covered with drywall. An examination of the crawlspace revealed the absence of shear panels on the cripple walls. The installation of shear panels on the cripple walls is recommended as an upgrade.

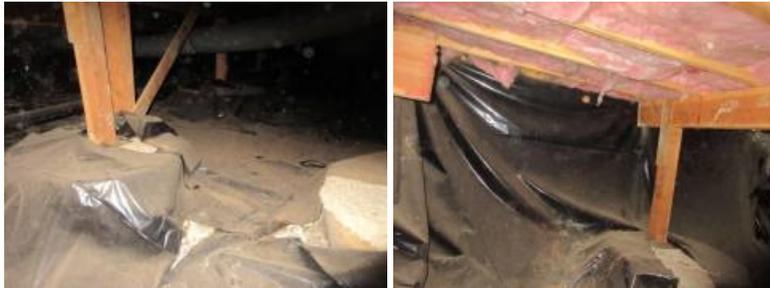
The support post concrete piers are covered with the plastic vapor retarder. This allows the transmission of water vapor from the soil up and into the floor framing. The plastic vapor retarder should be removed from the pier so that it covers at least 85% of the entire surface of the soil only.

The foundation walls are covered with the plastic vapor retarder. This allows the transmission of water vapor from the soil up and into the exterior wall framing. The plastic vapor retarder should be removed from the foundation so that it covers at least 85% of the entire surface of the soil only.

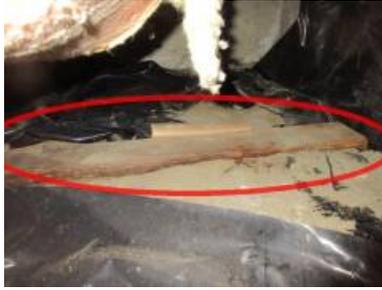
Good building practice requires that foundation walls or pier footings supporting wood frame construction, should extend at least 8" above the finish grade with at least a 6" clearance between the top of the soil and the bottom of the wood finish materials. Untreated wood should be raised 1-2" above surrounding flatwork and should have a moisture barrier such as 30 lb. asphalt impregnated felt installed between the concrete and wood. For additional information and treatment options, you

should retain the services of a qualified pest control operator.
