NOTICE TO BUYER: SELLER-PROCURED INSPECTION REPORT

March 24, 2021

Re: 13715 180th Ave. NE
Redmond, WA.

At your request, a visual inspection of the above referenced property was conducted on 03/22/2021. We have inspected the major structural components, plumbing, heating and electrical systems for signs of significant non-performance, excessive or unusual wear and general state of repair.

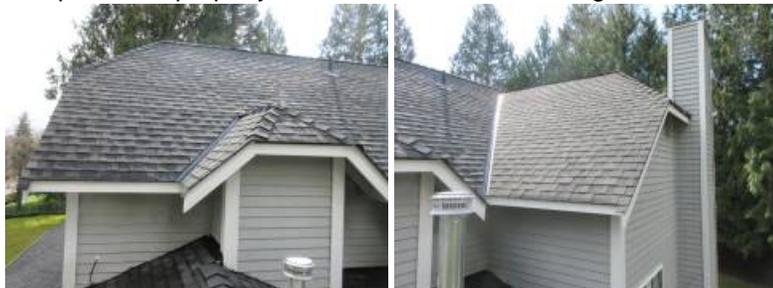
Gutters are missing from the upper roof runoff of the building. Gutters should be installed to prevent water splash on the siding and saturated soils adjacent building components.

The lower roof runoff is collected and channeled into the downspouts by aluminum gutters fastened to the rafter tails. The gutters and downspouts are properly installed and are performing their intended function. Gutters should be cleaned regularly to prevent clogging and overflow. The downspouts are properly installed and are functioning as intended.
