NOTICE TO BUYER: SELLER-PROCURED INSPECTION REPORT

July 28, 2021

Re: 13702 178th Ave. NE
Redmond, WA.

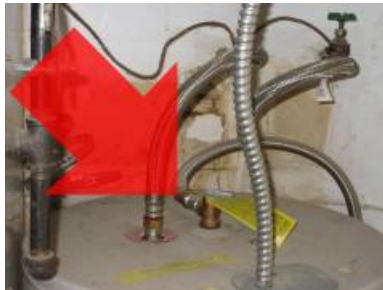
The pressure relief valve drain pipe has a reverse slope which traps water in the pipe. This can result in failure of the pressure relief valve. The drain pipe should be reconfigured so that it slopes 1/4" per foot to the drain outlet. If this is not possible or practical, a small (1/16") drain hole can be drilled in the bottom of the pipe at the lowest point.
