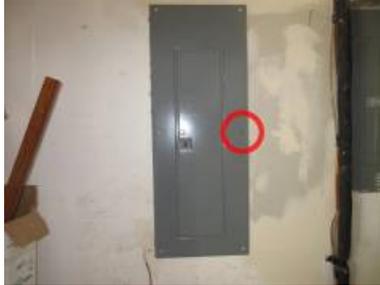
Screws that secure the panel cover to the panel box are missing. This is a potential hazard. Missing screws should be replaced with the original style blunt end screws.

The circuits are labeled. The accuracy of the labeling was not verified. Do not assume the labeled circuit is off unless it has been checked with a voltage tester.

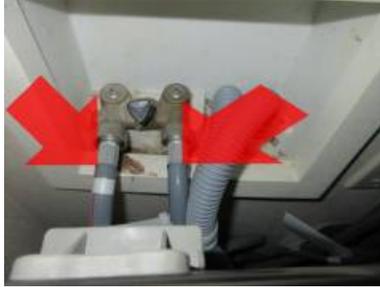
The hookups for the dryer are properly installed and in serviceable condition. The dryer itself was operated through a partial cycle, however we did not confirm the complete operation of the cycle timer.

High pressure (steel braided) washer line connections is recommended.

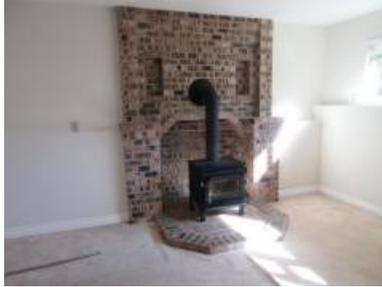
16.3 WOOD STOVE

The visible portions of the wood stove, smoke pipe and chimney are properly installed and are performing their intended function. It is essential that combustible materials be kept a minimum of 36" away from the wood stove when it is in operation.
