NOTICE TO BUYER: SELLER-PROCURED INSPECTION REPORT

**Ms. Frances Dunkin
17421 NE 140th Pl.
Redmond, WA.**

**Re: 17421 NE 140th Pl.
Redmond, WA.**

At your request, a visual inspection of the above referenced property was conducted on 09/21/2021. We have inspected the major structural components, plumbing, heating and electrical systems for signs of significant non-performance, excessive or unusual wear and general state of repair.

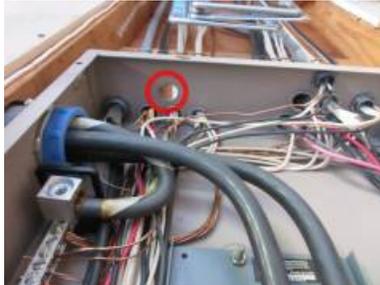
There are openings in the panel box where knock-outs have been removed. Missing knock-outs should be replaced with snap in metal plugs.

The circuits are labeled. The accuracy of the labeling was not verified. Do not assume the labeled circuit is off unless it has been checked with a voltage tester.

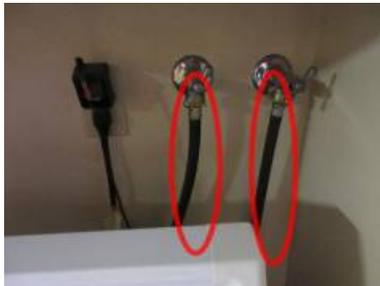
The hookups for the dryer are properly installed and in serviceable condition. The dryer itself was operated through a partial cycle, however we did not confirm the complete operation of the cycle timer.

High pressure (steel braided) washer line connections is recommended.
