TIME OF SALE OSS INSPECTION REPORT: TOS

Application No: 109213

12503 179TH AVE NE
KING COUNTY, WA

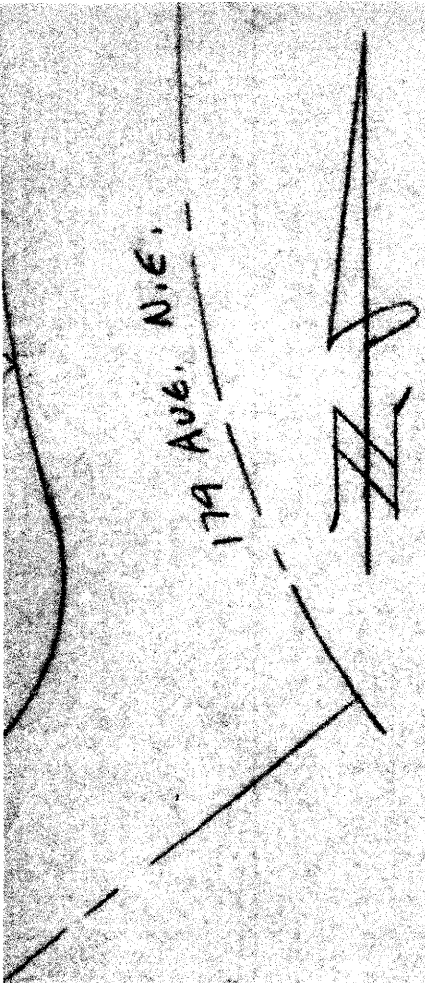
Record Drawing Date: 5.10.22
 Address: 12503 179th AVE NE
 REDMOND WA 98052
 Parcel #: 5649300060
 Darren McCullough OSM# 64 | MH# 174

REVIEWER - 4/18/2022 - Updated site drawing indicates pond and creek are less than 100 feet from the septic system. Current codes do not allow septic systems within one hundred feet of surface water due to risk of contamination from inadequately treated sewage.

SEPTIC TANK PUMPED
PUMP TANK PUMPED
LOAD TEST PERFORMED - 150 GAL = NO RUN-BACK OBSERVED
THERE ARE REMOVABLE PAVERS OVER TANKS CREATING AN ENCROACHMENT
SYSTEM APPEARS TO BE FUNCTIONING PROPERLY AT TIME OF INSPECTION
Modified drawing to reflect driveway and pavers over tank

MODIFICATION DRIVENWAY. PAVERS OVER TANK
