**NOTICE TO BUYER: SELLER-PROCURED INSPECTION REPORT**

**David P Walsh & Nicola Thornton-Walsh**  
**18356 NE 143<sup>rd</sup> PL**  
**Woodinville, WA, 98072**

**Per the seller, the following items listed on the pre-sale inspection summary dated (03/26/2022), are being corrected by the seller as part of preparation for sale in good faith.**

At your request, a visual inspection of the above referenced property was conducted on 03/24/2022. We have inspected the major structural components, plumbing, heating and electrical systems for signs of significant non-performance, excessive or unusual wear and general state of repair.

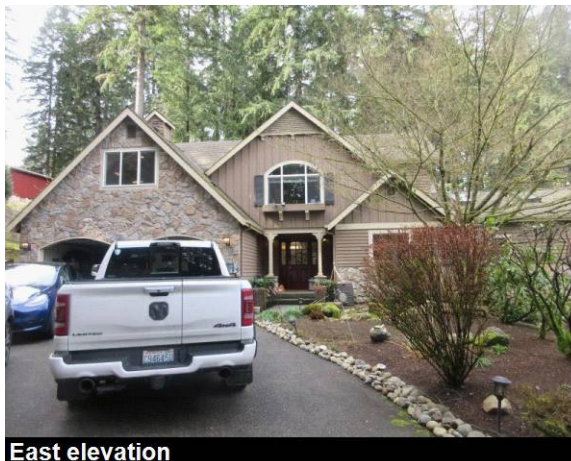
**1.6 ADDRESS OF PROPERTY INSPECTED**

18356 NE 143rd Pl.  
Woodinville WA.

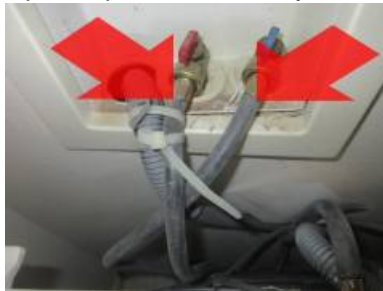
The hookups for the dryer are properly installed and in serviceable condition. The dryer itself was operated through a partial cycle, however we did not confirm the complete operation of the cycle timer.

Upgrading the washer connections to high pressure (steel braided) lines is recommended.
