NOTICE TO BUYER: SELLER-PROCURED INSPECTION REPORT

**Renata Beglarian & Arman Avetisian
17016 NE 131st Pl,
Redmond WA 98052**

At your request, a visual inspection of the above referenced property was conducted on 06/10/2023. We have inspected the major structural components, plumbing, heating and electrical systems for signs of significant non-performance, excessive or unusual wear and general state of repair.

DATE OF INSPECTION: 6/10/2023.
 INSPECTOR'S NAME: Terry Clark.
 CLIENT NAME: Mr. Arman Avetisian & Ms. Renata Beglarian.
 MAILING ADDRESS: 17016 NE 131st Pl.
 Redmond WA.
 CLIENT E-MAIL ADDRESS armanavs999@gmail.com; bejlaren@gmail.com.
 ADDRESS OF PROPERTY 17016 Northeast 131st Pl.
 INSPECTED Redmond WA.

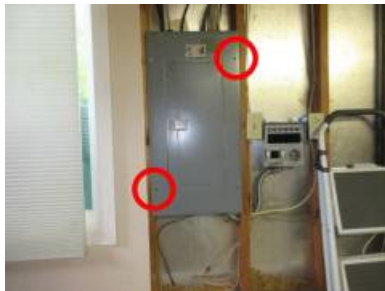
Screws that secure the panel cover to the panel box are missing. This is a potential hazard. Missing screws should be replaced with the original style blunt end screws.

The circuits are labeled. The accuracy of the labeling was not verified. Do not assume the labeled circuit is off unless it has been checked with a voltage tester.
