NOTICE TO BUYER: SELLER-PROCURED INSPECTION REPORT

March 2, 2025

Re: 17433 NE 139th Pl.
Redmond, WA.

At your request, a visual inspection of the above referenced property was conducted on 03/01/2025. We have inspected the major structural components, plumbing, heating and electrical systems for signs of significant non-performance, excessive or unusual wear and general state of repair.

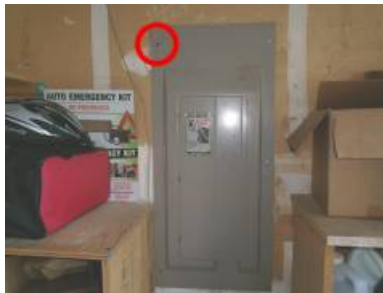
Screws that secure the panel cover to the panel box are missing. This is a potential hazard. Missing screws should be replaced with the original style blunt end screws.

The circuits are labeled. The accuracy of the labeling was not verified. Do not assume the labeled circuit is off unless it has been checked with a voltage tester.

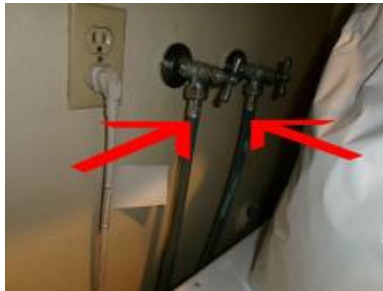
The hookups for the dryer are properly installed and in serviceable condition. The dryer itself was operated through a partial cycle, however we did not confirm the complete operation of the cycle timer.

Upgrading the washer connections to high pressure (steel braided) lines is recommended.
