**NOTICE TO BUYER: SELLER-PROCURED INSPECTION REPORT**

Jim and Maryann Purkey  
17042 NE 133rd St  
Redmond, WA 98052

April 21, 2021

**Mr. & Mrs. Jim & Maryann Purkey  
17042 NE133rd St.  
Redmond, WA.**

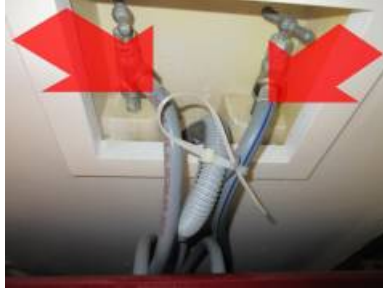
There are hookups for both gas and electric dryers.

The hookups for the dryer are properly installed and in serviceable condition. The dryer itself was operated through a partial cycle, however we did not confirm the complete operation of the cycle timer.
