NOTICE TO BUYER: SELLER-PROCURED INSPECTION REPORT

April 22, 2021

**Re: 12903 176th Pl. NE
Redmond, WA.**

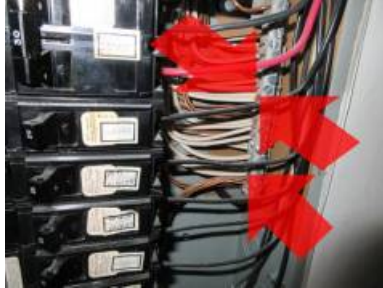
Several of the neutral wires are double tapped on the buss bar. Double tapping means that two conductors share a single terminal. Double tapped terminals can loosen and overheat and therefore are not permitted unless the terminal is specifically listed for multiple wires. This defect is easily repaired by connecting the two wires to a "pig tail", securing them with a wire cap, and then inserting the pig tail conductor under the terminal.

The circuits are labeled. The accuracy of the labeling was not verified. Do not assume the labeled circuit is off unless it has been checked with a voltage tester.

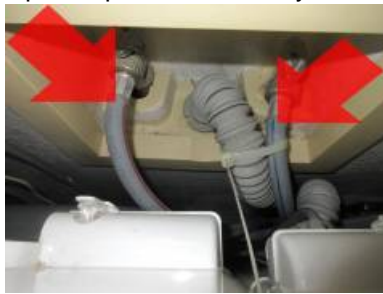
The hookups for the dryer are properly installed and in serviceable condition. The dryer itself was operated through a partial cycle, however we did not confirm the complete operation of the cycle timer.

Upgrading the washer connections to high pressure (steel braided) lines is recommended.

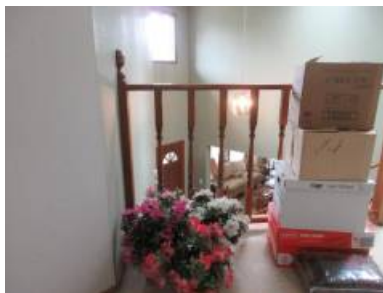
16.3 GUARD RAILINGS

The spacing between the balusters is too wide. This is a hazard to small children. The balusters should be spaced close enough together so that a 4" sphere cannot pass through. Upgrading the guard railing is recommended if small children are present.

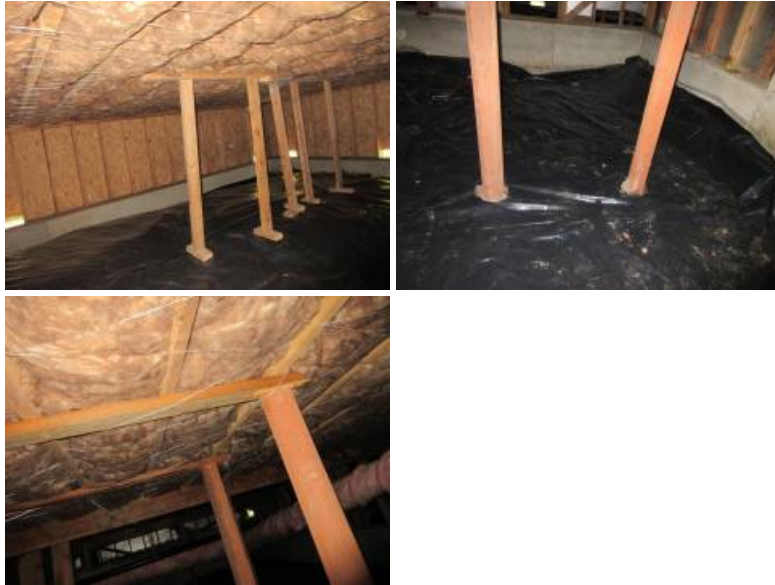
The visible portions of the posts and beams are properly installed and are performing their intended function. However several posts have been propped up under the south extension floor and are improperly braced and supported. Replacement if needed should be done under current industry standards.

Two posts have been propped up under the kitchen floor and is improperly supported. Replacement if needed should be done under current industry standards.

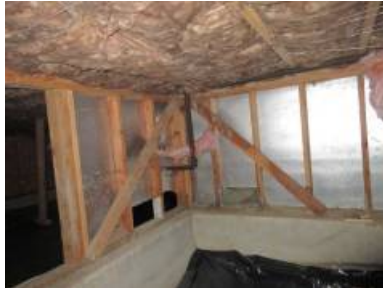
20.6 SHEAR PANELS

Shear panels are plywood or OSB panels that are mechanically fastened to both vertical and horizontal framing members in critical structural areas of the building. They prevent lateral movement of the structure during an earthquake. Shear panels are often visible in the crawlspace on cripple walls between the first floor and foundation. They may also be installed on interior walls that are covered with drywall. An examination of the crawlspace revealed the absence of shear panels on the cripple walls. The installation of shear panels on the cripple walls is recommended as an upgrade.

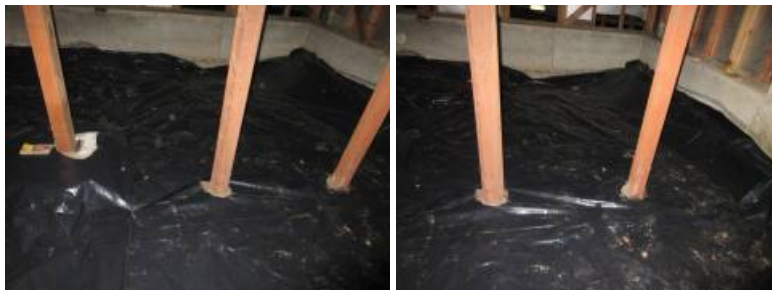
The support post concrete piers are covered with the plastic vapor retarder. This allows the transmission of water vapor from the soil up and into the floor framing. The plastic vapor retarder should be removed from the pier so that it covers at least 85% of the entire surface of the soil only.
