**NOTICE TO BUYER: SELLER-PROCURED INSPECTION REPORT**

Ron and Debbie Porterfield
13901 177th PL NE
Redmond, WA 98052

At your request, a visual inspection of the above referenced property was conducted on 07/13/2021. We have inspected the major structural components, plumbing, heating and electrical systems for signs of significant non-performance, excessive or unusual wear and general state of repair.

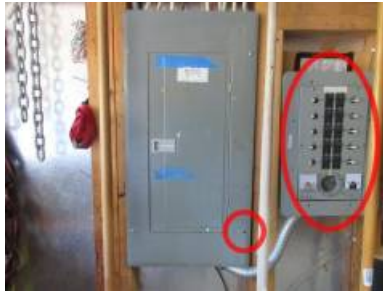
Screws that secure the panel cover to the panel box are missing. This is a potential hazard. Missing screws should be replaced with the original style blunt end screws.

The circuits are labeled. The accuracy of the labeling was not verified. Do not assume the labeled circuit is off unless it has been checked with a voltage tester.
