**NOTICE TO BUYER: SELLER-PROCURED INSPECTION REPORT**

**Durgaprasad & Lakshminadhuri Gorti**  
**17424 NE 139<sup>th</sup> PI**  
**Redmond, WA 98052**

At your request, a visual inspection of the above referenced property was conducted on 08/11/2021. We have inspected the major structural components, plumbing, heating and electrical systems for signs of significant non-performance, excessive or unusual wear and general state of repair.

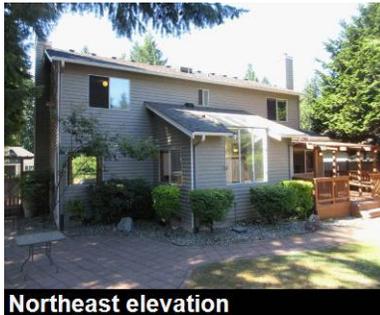
Northeast elevation

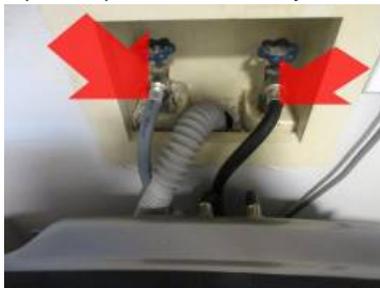
The hookups for the dryer are properly installed and in serviceable condition. The dryer itself was operated through a partial cycle, however we did not confirm the complete operation of the cycle timer.

High pressure (steel braided) washer line connections is recommended.
