# NOTICE TO BUYER: SELLER-PROCURED INSPECTION REPORT

**Michael Salamone and Wenting Cai**  
**17302 NE 131st St**  
**Redmond, WA 98052**

**Per the seller, the following items listed on the pre-sale inspection summary dated February 15, 2022, are being corrected by the seller as part of preparation for sale in good faith.**

At your request, a visual inspection of the above referenced property was conducted on 02/15/2022. We have inspected the major structural components, plumbing, heating and electrical systems for signs of significant non-performance, excessive or unusual wear and general state of repair.

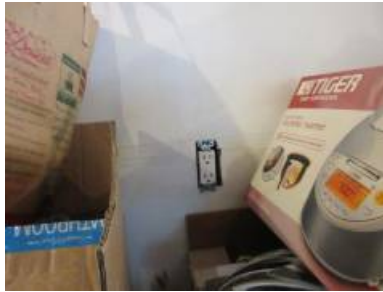
The cover plates are missing from several receptacles. This is a shock and fire hazard. The installation of a cover plates is

recommended.
