NOTICE TO BUYER: SELLER-PROCURED INSPECTION REPORT

**Mr. & Mrs. Ekkehard & Gabi Priss
13833 174th Pl. NE
Redmond, WA.**

At your request, a visual inspection of the above referenced property was conducted on 02/08/2023. We have inspected the major structural components, plumbing, heating and electrical systems for signs of significant non-performance, excessive or unusual wear and general state of repair.

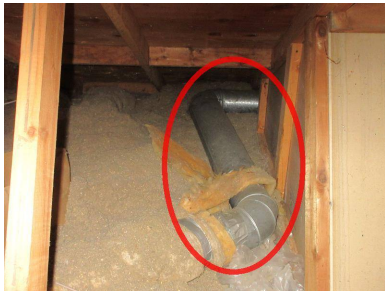
8.12 DUCTS

The ducts are constructed out of sheet metal. The ducts are properly installed and are performing their intended function.

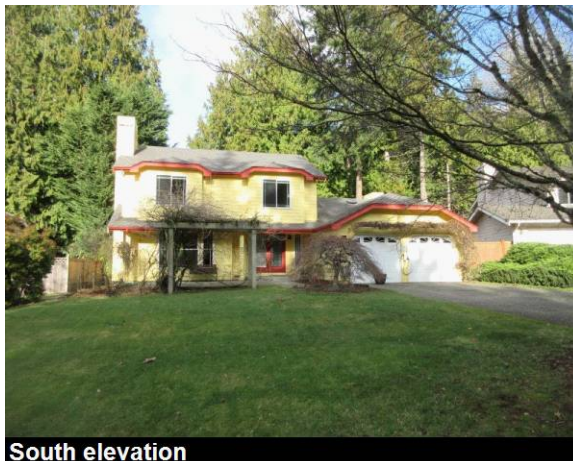
South elevation

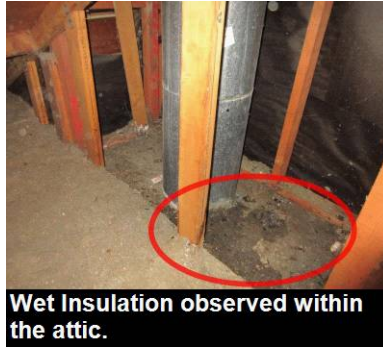
4.5 GAS APPLIANCE VENTS

The visible portion of the gas appliance type B vent is properly installed and in good condition.

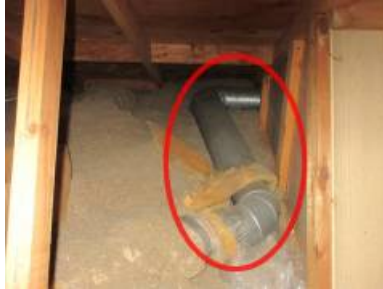
8.12 DUCTS

The ducts are constructed out of sheet metal. The ducts are properly installed and are performing their intended function.
